Navajo Abandoned Uranium Mine

Site Screen Report

Mine Name: Martin Johnson No. 4
Mine ID: 540

August 2011

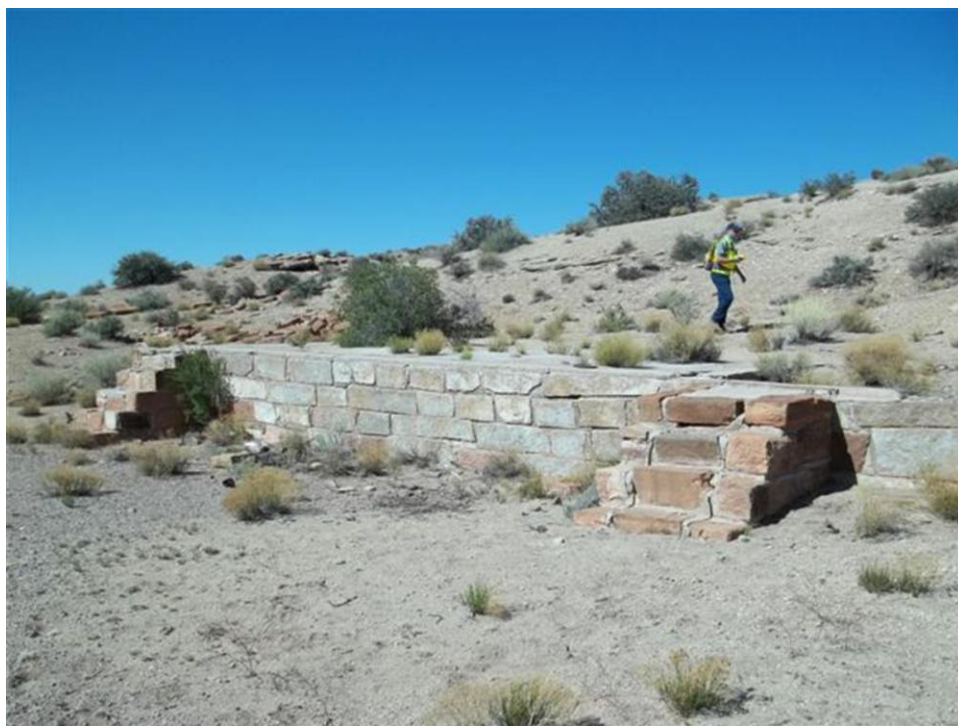
Photo 3: Mine Site #540; Stone foundation onsite

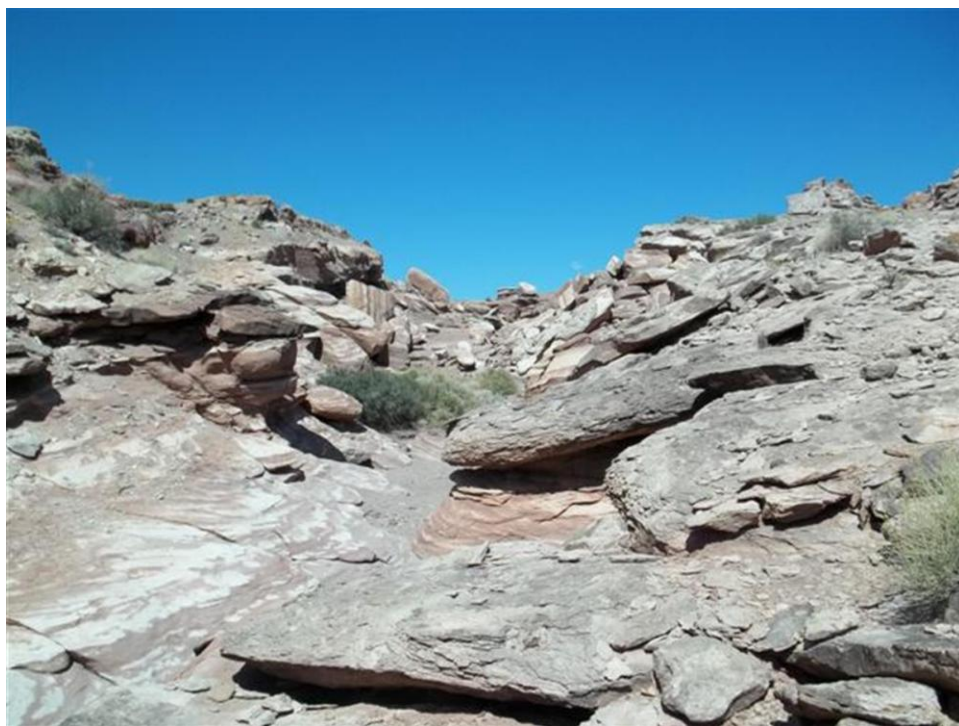
The site is located within a wash area which may contain seasonal tributaries to the Little Colorado River

Photo 5: Mine Site #540; Onsite drainage

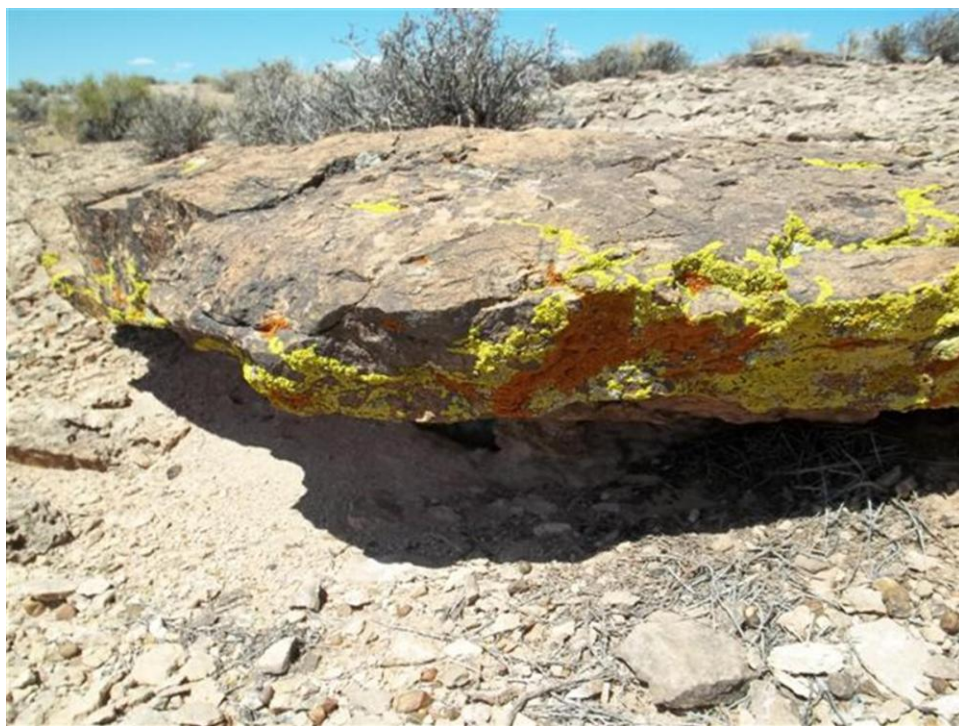
A total of 7,915 gamma radiation measurements were collected from the mine site, ranging from 9,986 cpm to 80,663 cpm. Measurements collected in the vicinity of the scattered loose rock were found at a maximum level of approximately 80,000 cpm. The measurements are represented in Figures 1 and 2.

Photo 6: Mine Site #540; Onsite rocks

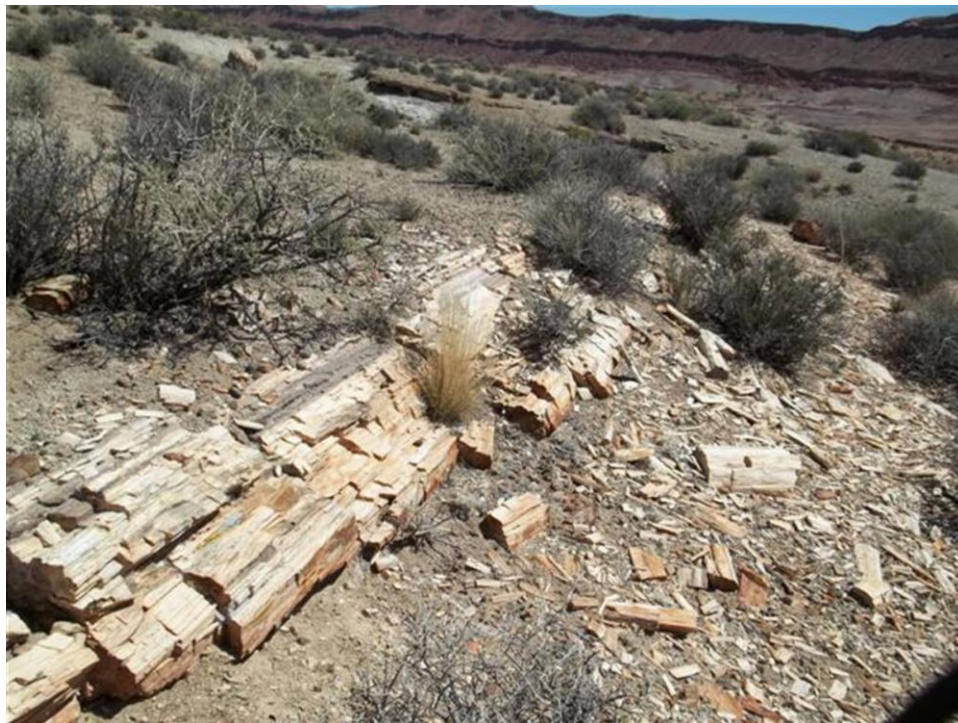
Photo 7: Mine Site #540; Petrified wood pile

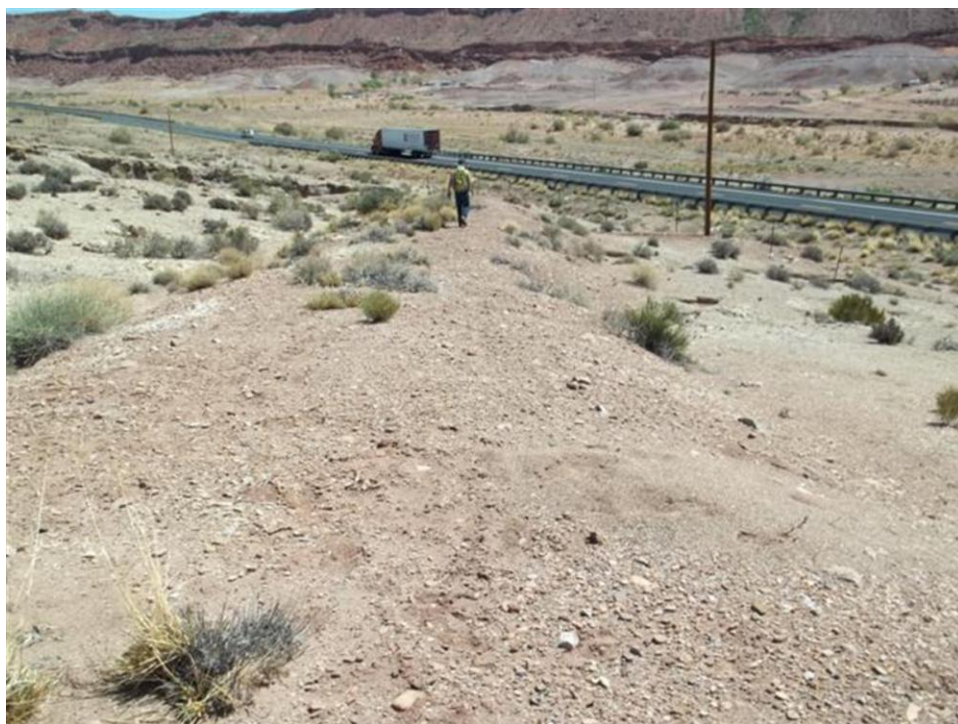
Photo 8: Mine Site #540; Berm

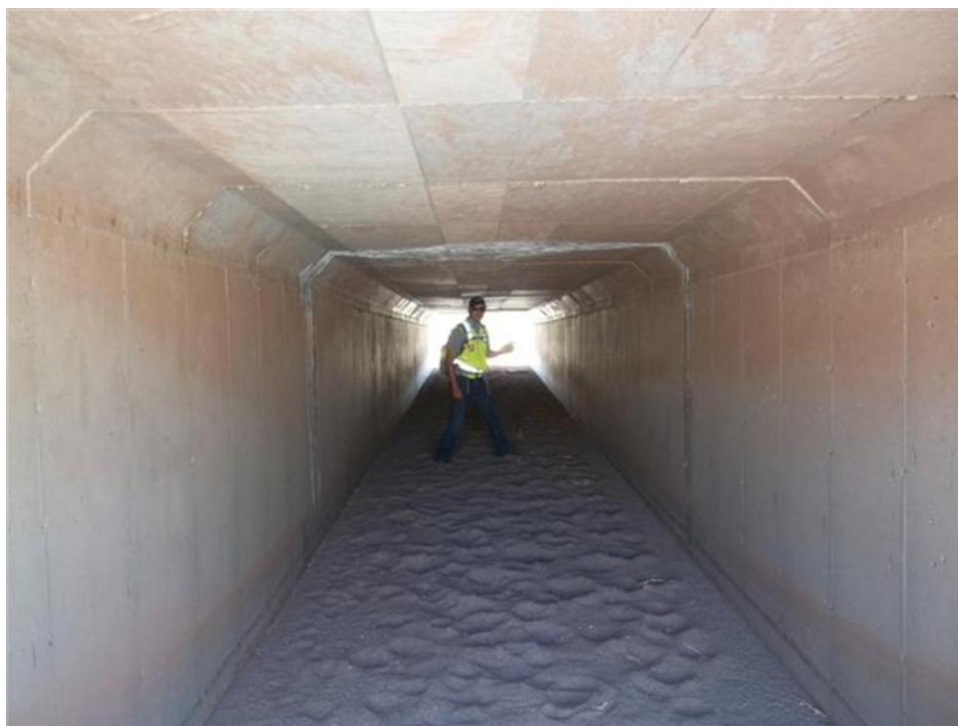
Photo 11: Mine Site #540; Culvert below Hwy 89
